# Ultrasonic Guided-Wave Scan System Used to Characterize Microstructure and Defects in Ceramic Composites

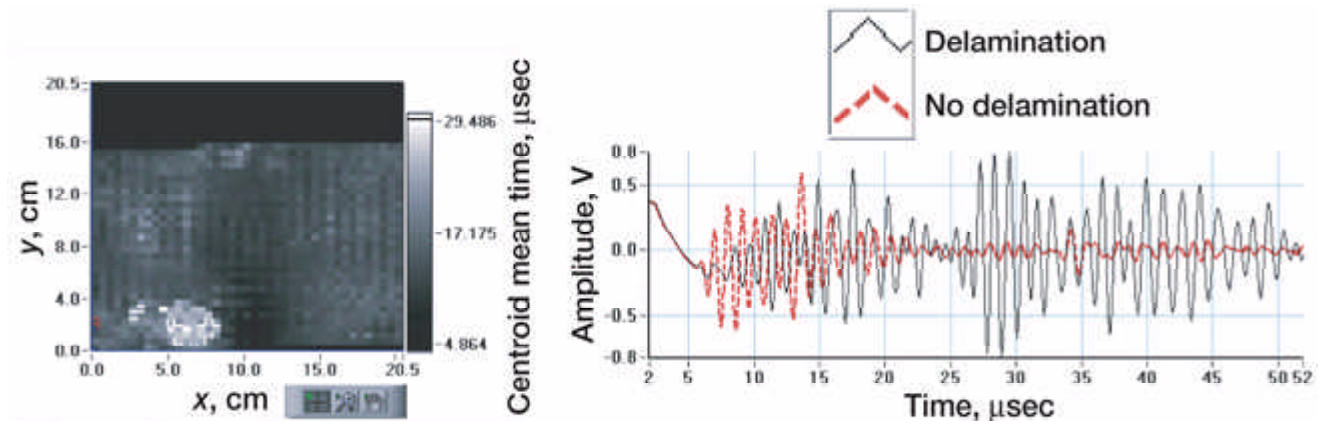
Left: Centroid mean time image (in  $\mu\text{sec}$ ) of SiC/SiC sample. The lower left whitish area is delaminated. Right: Time-domain waveforms associated with delaminated and nondelaminated areas.

The figure shows an ultrasonic guided-wave scan image of a SiC/SiC composite sample containing delamination. The delamination was most easily discriminated in the centroid mean time image (whitish areas in image; the signal processing performed allows over 20 parameters of the time and frequency domains to be calculated for image formation). Centroid mean time can be thought of as the time in the raw waveform demarcating the location of energy balance. The time-domain waveforms associated with the delaminated and nondelaminated areas are shown in the figure. The shift in the centroid mean time away from the origin is quite apparent for the delamination.
